Technical Report 62

The evolution of Jumpinpin Inlet

**Emma McCauley
Rodger Tomlinson**

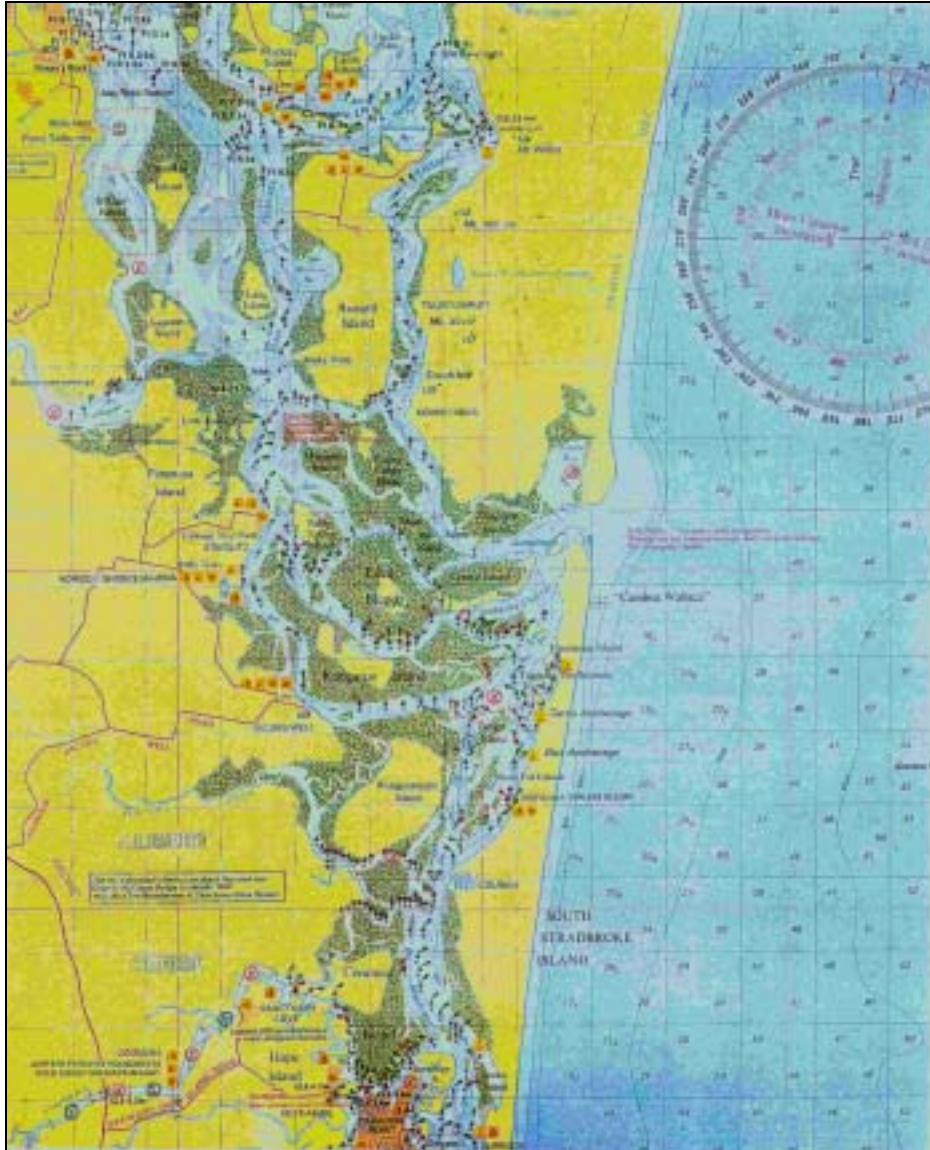
**Figure 3.2. Plan showing Jumpinpin and surrounds
(Source: Queensland Transport, June 1986)**

Jumpinpin Inlet is classified as microtidal, experiencing a maximum tidal range of 2 metres. Flow velocities are high at around 4.5 knots as recorded by the Department of Harbours and Marine (Maxwell, 1970). Such high flows are due to the small width to volume ratio at the entrance. It is believed that the waters of the Albert, Logan, Pimpama and Coomera rivers and tidal waters of the southern bay drain through the inlet. As Maxwell (1970) notes, tide flow direction is varied although it appears to be predominantly from the north.

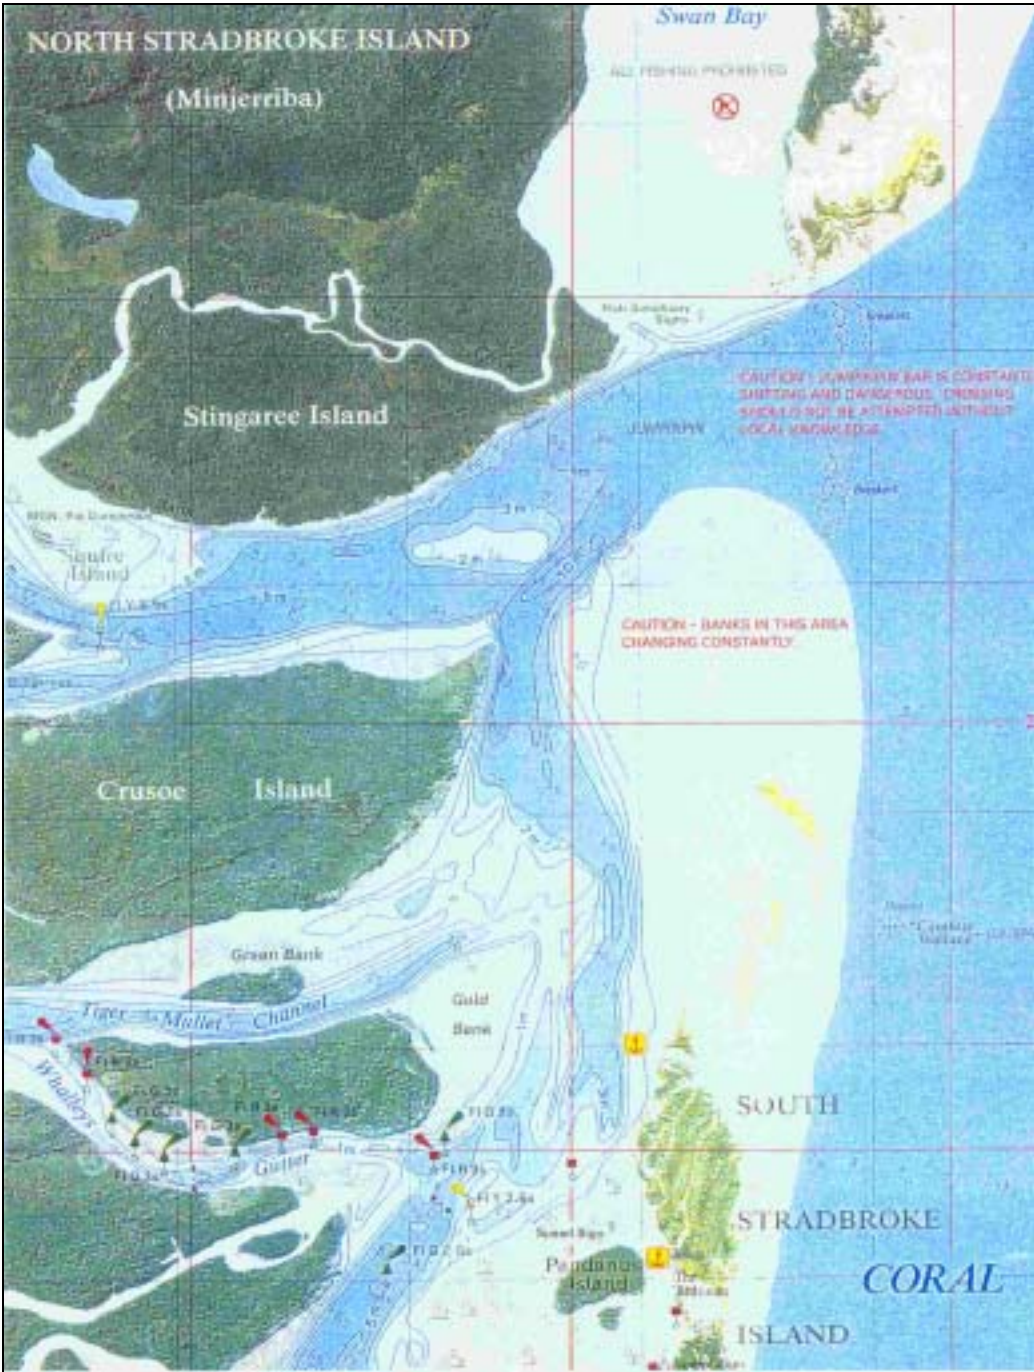
Figure 3.3. Detailed plan of Jumpinpin Inlet (Source: Queensland Transport, December 1981)

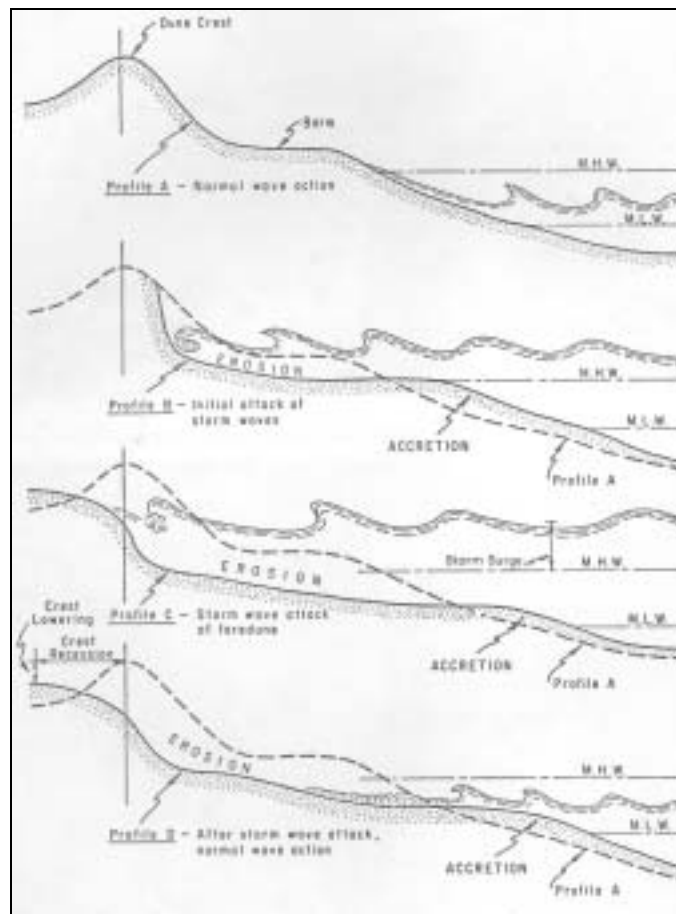
Figure 4.1. Schematic diagram of storm wave attack on beach and dune (Source: Shore Protection Manual, 1984)

The storm surge is especially damaging if it occurs concurrently with high astronomical tides. At locations where there are low sections of protective dunes, the storm surge and wave action can succeed in completely overtopping the dunes. The storm overwash and storm flooding return may erode enough sand to cut a new tidal inlet through a barrier island. This is the mechanism by which many new inlets are formed. However, as Hayes (1991) notes, most inlets formed in this way are closed off by swash-transported and wind-blown sand within weeks of the storm.

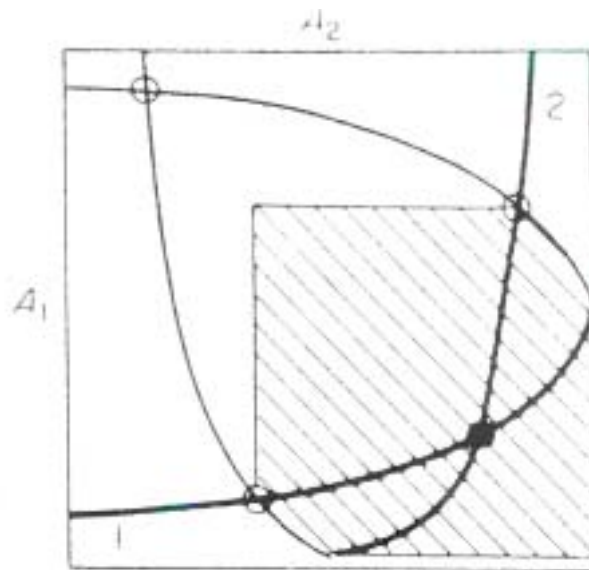
- Unstable equilibrium flow area
- Stable equilibrium flow area
- ▨ The stability interval for the stable equilibrium flow area

Figure 4.2. Possible configuration of equilibrium flow curves for two-inlet bay systems (Source: Van De Kreeke, 1990a)

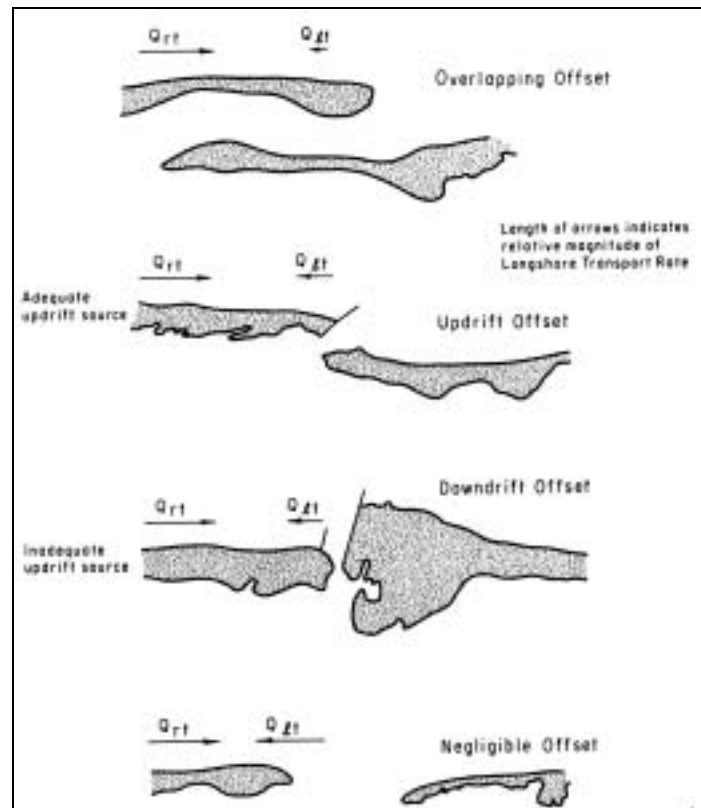
The geometry or pattern of sand storage of coastal inlets depends on the relative strengths of the inlet jet, the wave-driven littoral drift and the tidal and wave-driven components of the shelf flow field (Stanley & Swift, 1974). From detailed study of inlets through barrier islands in the United States, the pattern of sand storage at tidal inlets tends toward one of three basic patterns: overlap, symmetrical or offset inlets (Stanley & Swift, 1974), as shown in Figure 5.1.

Figure 5.1. The four shapes of barrier island inlets (Source: SPM, 1984)

Jumpinpin is seen to exhibit characteristics of a slight to negligible downdrift offset which would result from equal wave approach on both sides (SPM, 1984). Yet, where moderate gross rates of littoral drift are associated with a strong rate of net drift, as is the case at Jumpinpin (C.O.P.E, 1985), the situation favours an updrift offset. The lack of such an offset must be due to local processes which this study aims to identify.

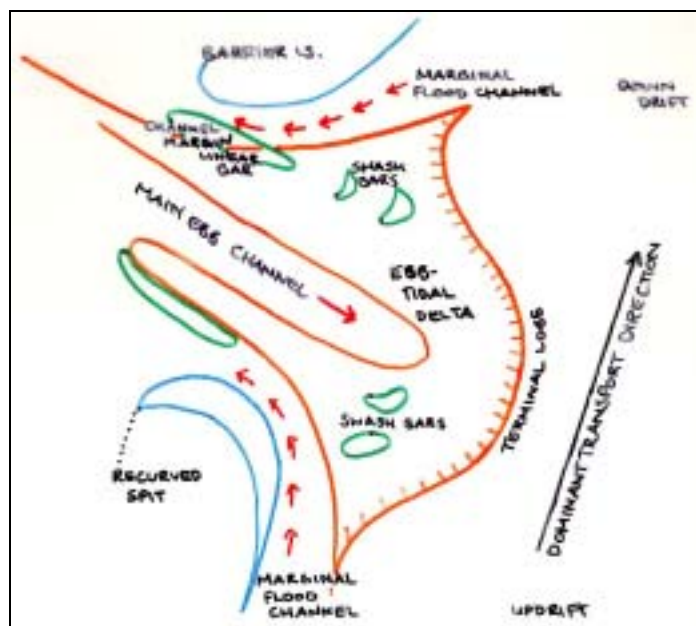
Figure 5.2. Typical ebb-tidal delta morphology
(Source: Adapted from Hayes, 1991)

Three major forms of sediment accumulation are associated with the ebb-tidal delta at Jumpinpin: (1) Asymmetrical swash bars oriented landward and forming a broken semicircle around the perimeter of the delta; (2) channel margin linear sand bars that trend perpendicular to shore and parallel to the main channel; and (3) a subaqueous terminal lobe deposited seaward of the main channel ebb currents. These characteristics are shown in the diagram below (Figure 5.2) and are best seen in the 1965 aerial photograph (see Appendix B, Figure B.3).

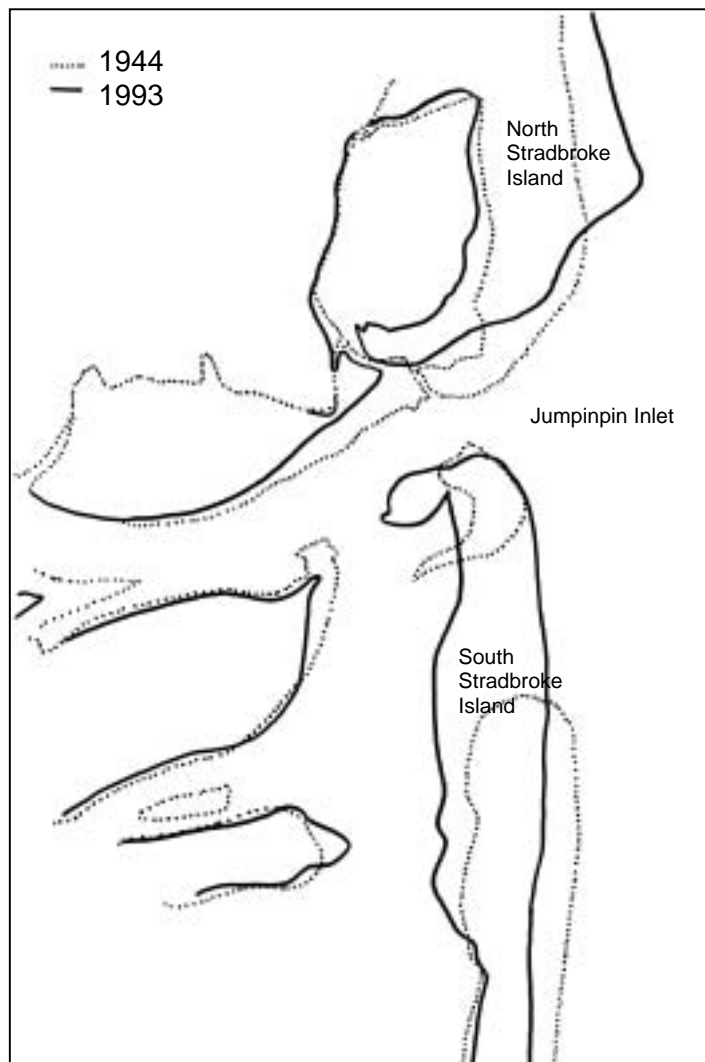
Net changes are derived from comparison of the 1944 aerial photograph to the 1993 aerial photographs and are shown in Figure 8.2. It should be noted that this comparison is inadequate in that it does not reflect gross volumes of accretion and erosion or cyclic patterns of change.

Figure 8.2. Net shoreline changes, 1944 to 1993

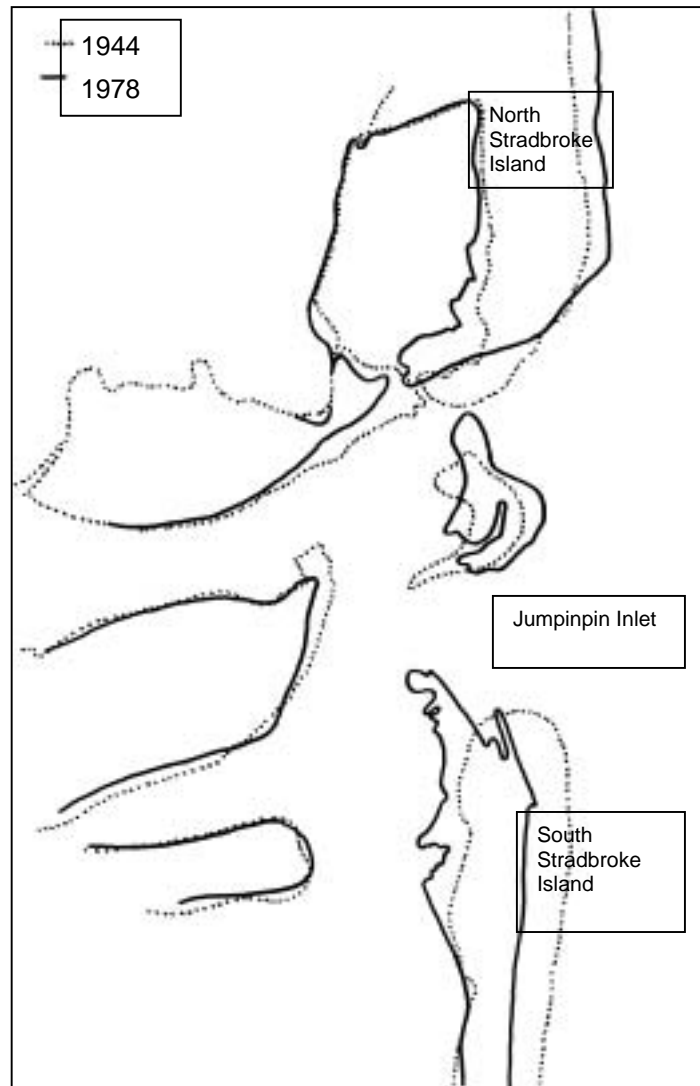
- The northern channel is located about 275 metres north in 1978.
- North Stradbroke has moved to the east.
- The recurved spit of South Stradbroke has shifted west.
- The entrance to Swan Bay has moved north and west. The eastern rim infilled.

Figure 8.3. Shoreline comparison, 1944 to 1978

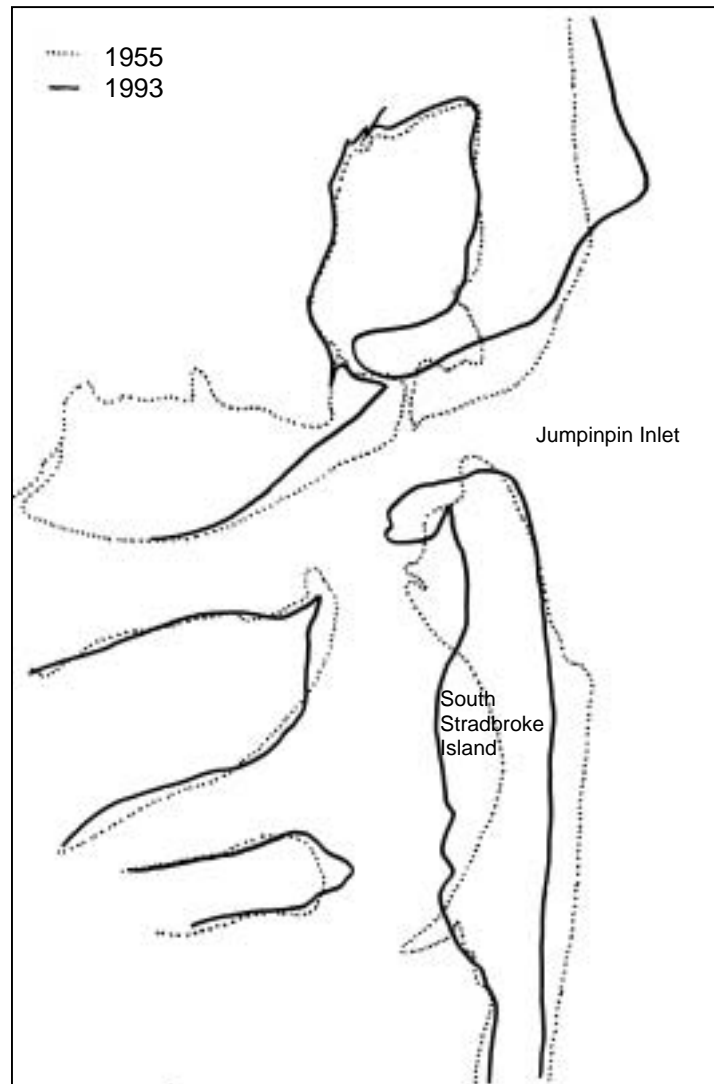
The aerial photograph of 1955 has been compared to 1993 (Figure 8.4) as they show Jumpinpin in similar stages of evolution. This time only the northern channel is active.

Figure 8.4. Shoreline comparison, 1955 to 1993

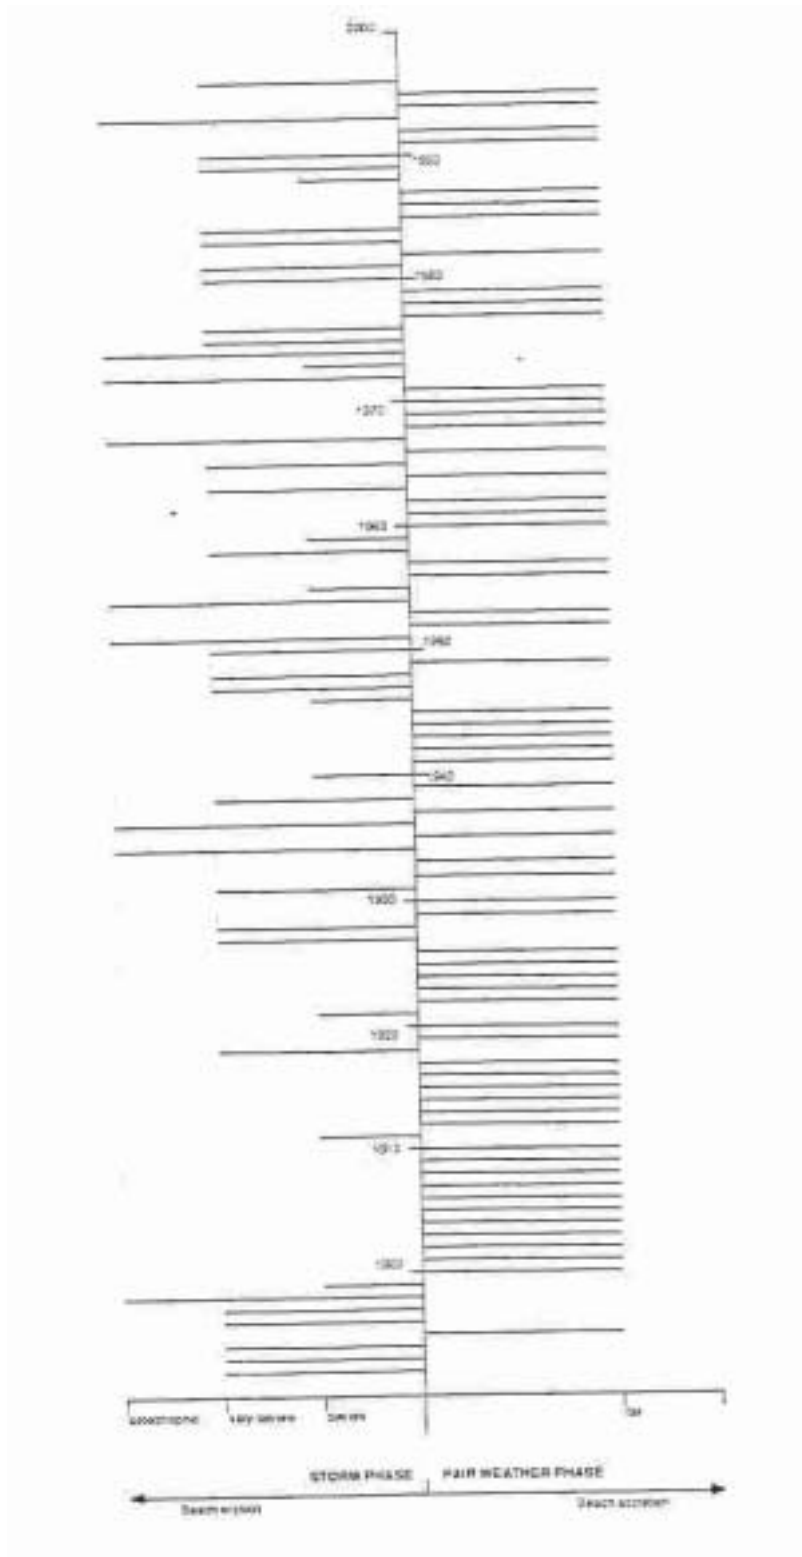
Figure 9.1. Summary of storm attack and fair weather on the southern Queensland coast

Figure 9.1 is useful in highlighting times of expected beach erosion or accretion. It can be seen that Jumpinpin experienced several periods of varying weather patterns: (1) severe or very severe weather; (2) isolated incidents of catastrophic weather; (3) incidents of catastrophic weather on top of severe weather; and (4) stages of fair weather. Other factors in determining extent of damage are important, for example the direction of cyclone approach. However, the most damaging weather occurs when a catastrophic event manifests before and/or after a series of severe events.

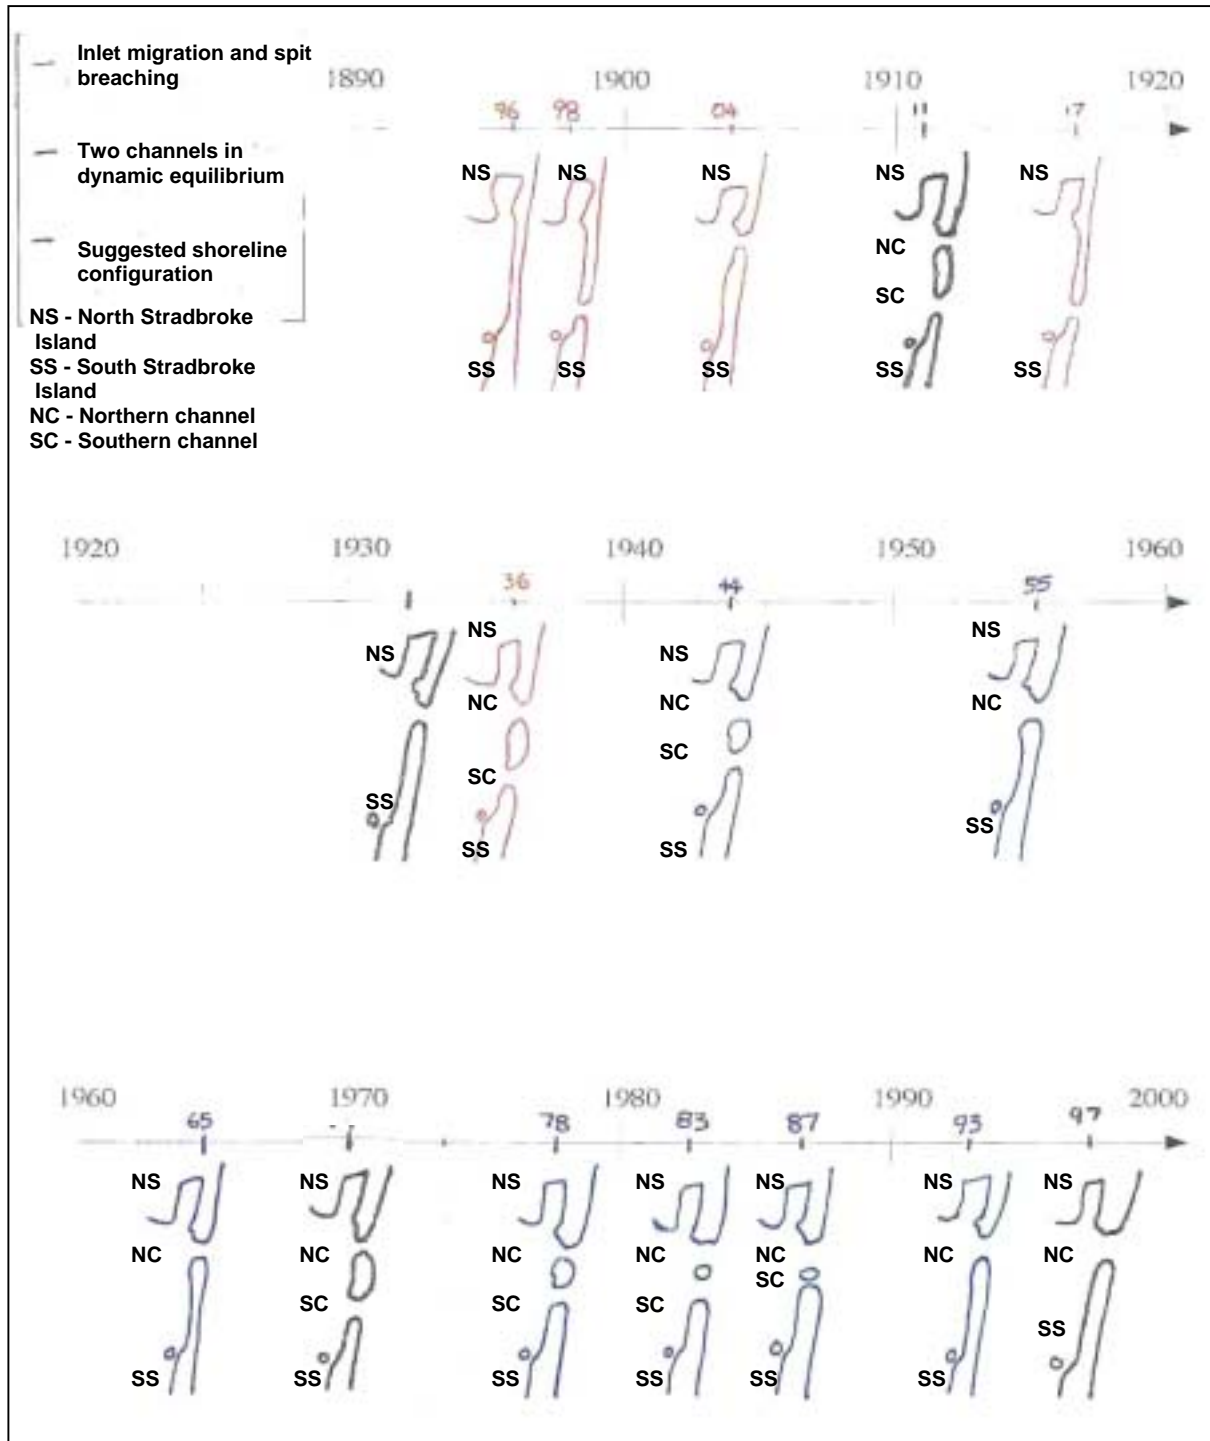
Figure 10.1. Conceptual model of shoreline change at Jumpinpin

In 1944 the two channels were still open, though this time the northern channel remained at critical cross-sectional area and the southern channel showed signs of closing. The fact that the northern channel remained open is probably due to the direction of approach of Canaipa Passage. From 1944 to 1955, consumption of littoral drift in building the recurved spit halted migration of the northern channel. In the 1940s there was a long period of fair weather which assisted growth of the spit. Sand

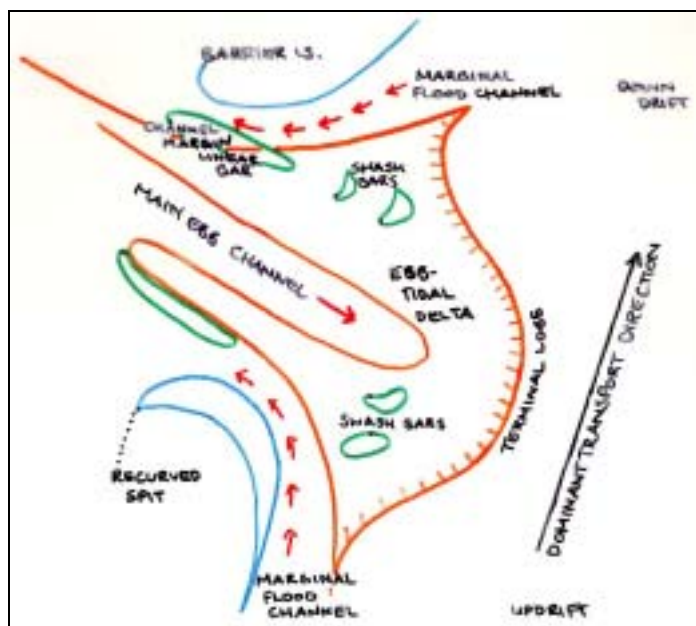
Figure A.2. Visual definition of the morphological components of a typical tidal inlet (Source: Adapted from Hayes, 1991)

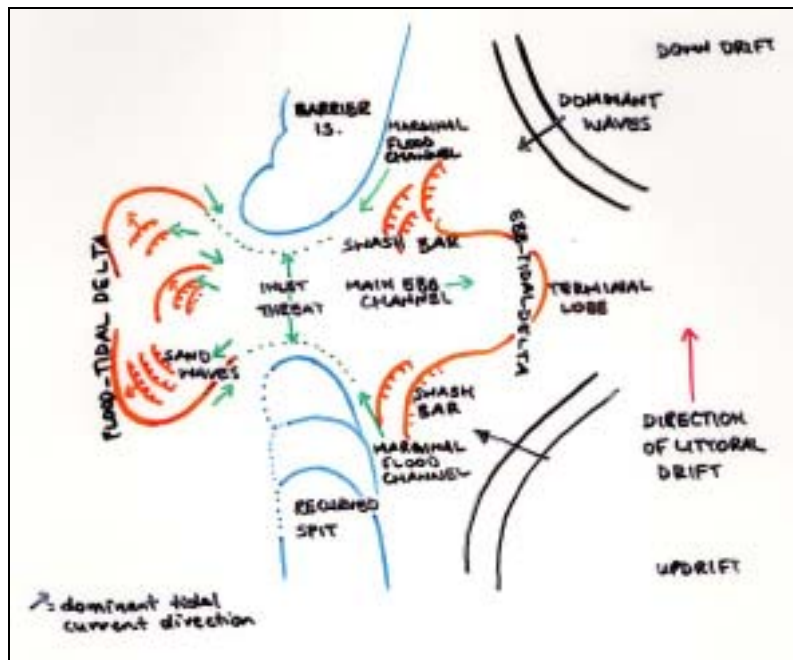
Figure A.3. Visual definition of terms describing an ebb-tidal delta
(Source: Adapted from Hayes, 1975)

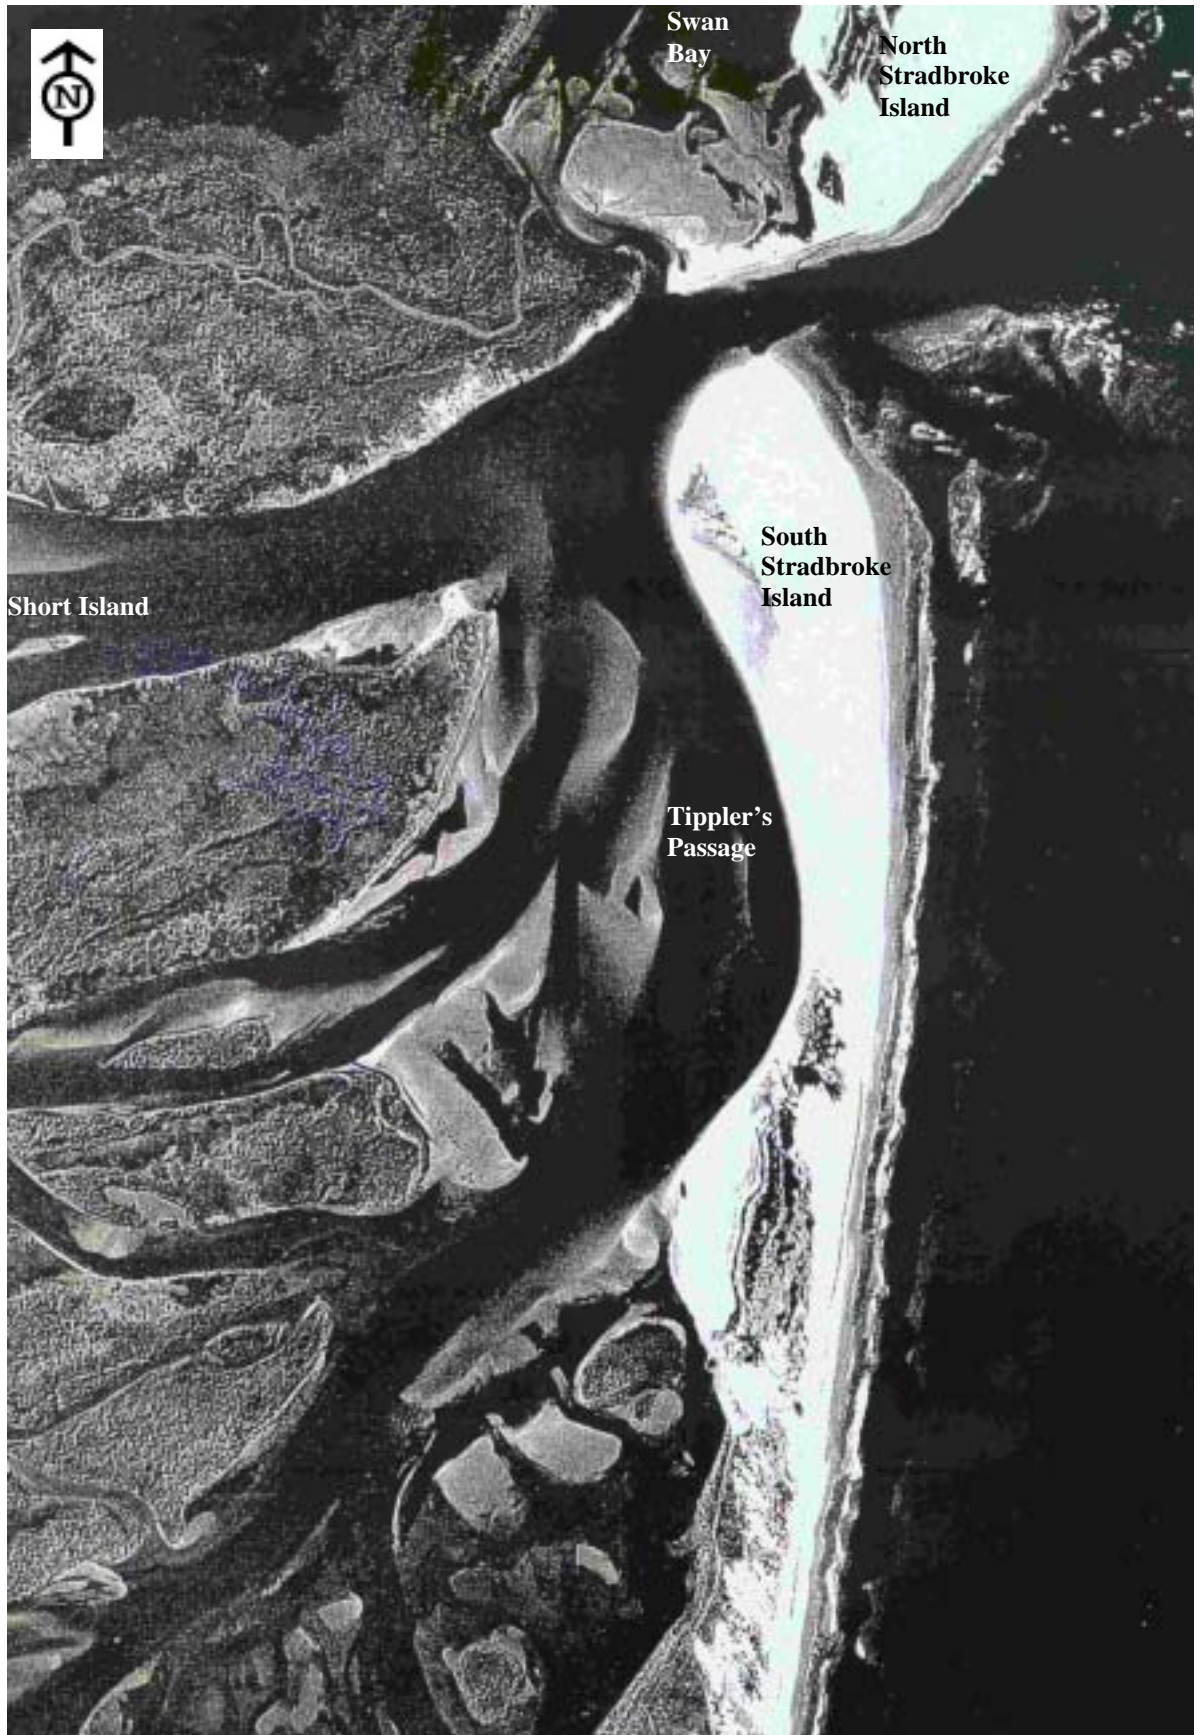
Figure B.3. 1965 Aerial photograph of Jumpinpin inlet

A common feature of ebb-tidal deltas shown in the 1965 aerial is the segregation of ebb and flood flow. The primary channel at Jumpinpin has a main channel oriented perpendicular to the shoreline which carries a large portion of the ebb flow. The flood flow tends to be distributed as a sheet, with a number of flood channels. These channels hug both beaches.

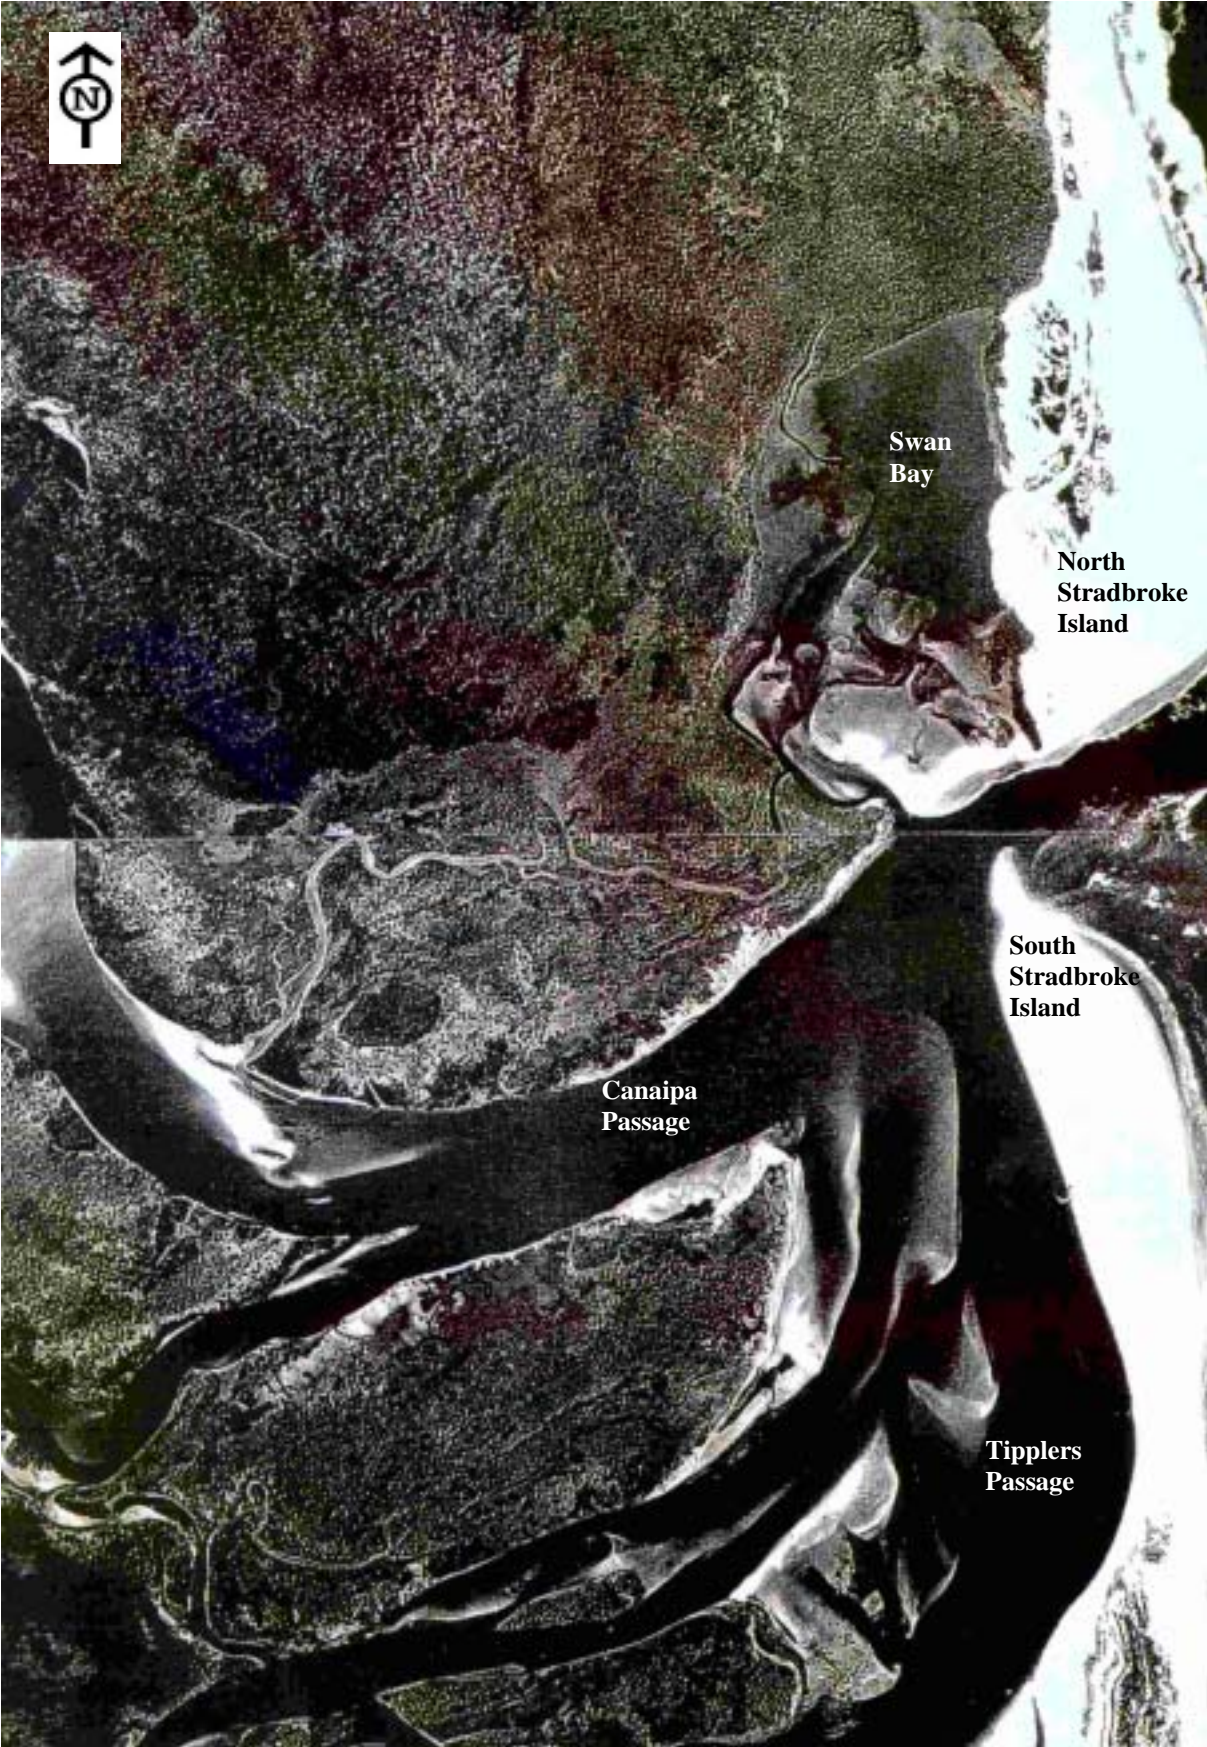
Figure B.4. 1970 Aerial photograph of Jumpinpin Inlet

Between 1965 and 1970, the inlet migrated to the north perhaps 75 metres and narrowed (Figure 8.1; Figure B.4). North Stradbroke offset increased. South Stradbroke spit narrowed even further with only about 275 metres of sand separating Tipplers Passage from the sea. These conditions may be similar to those prior to the 1936 cyclone.

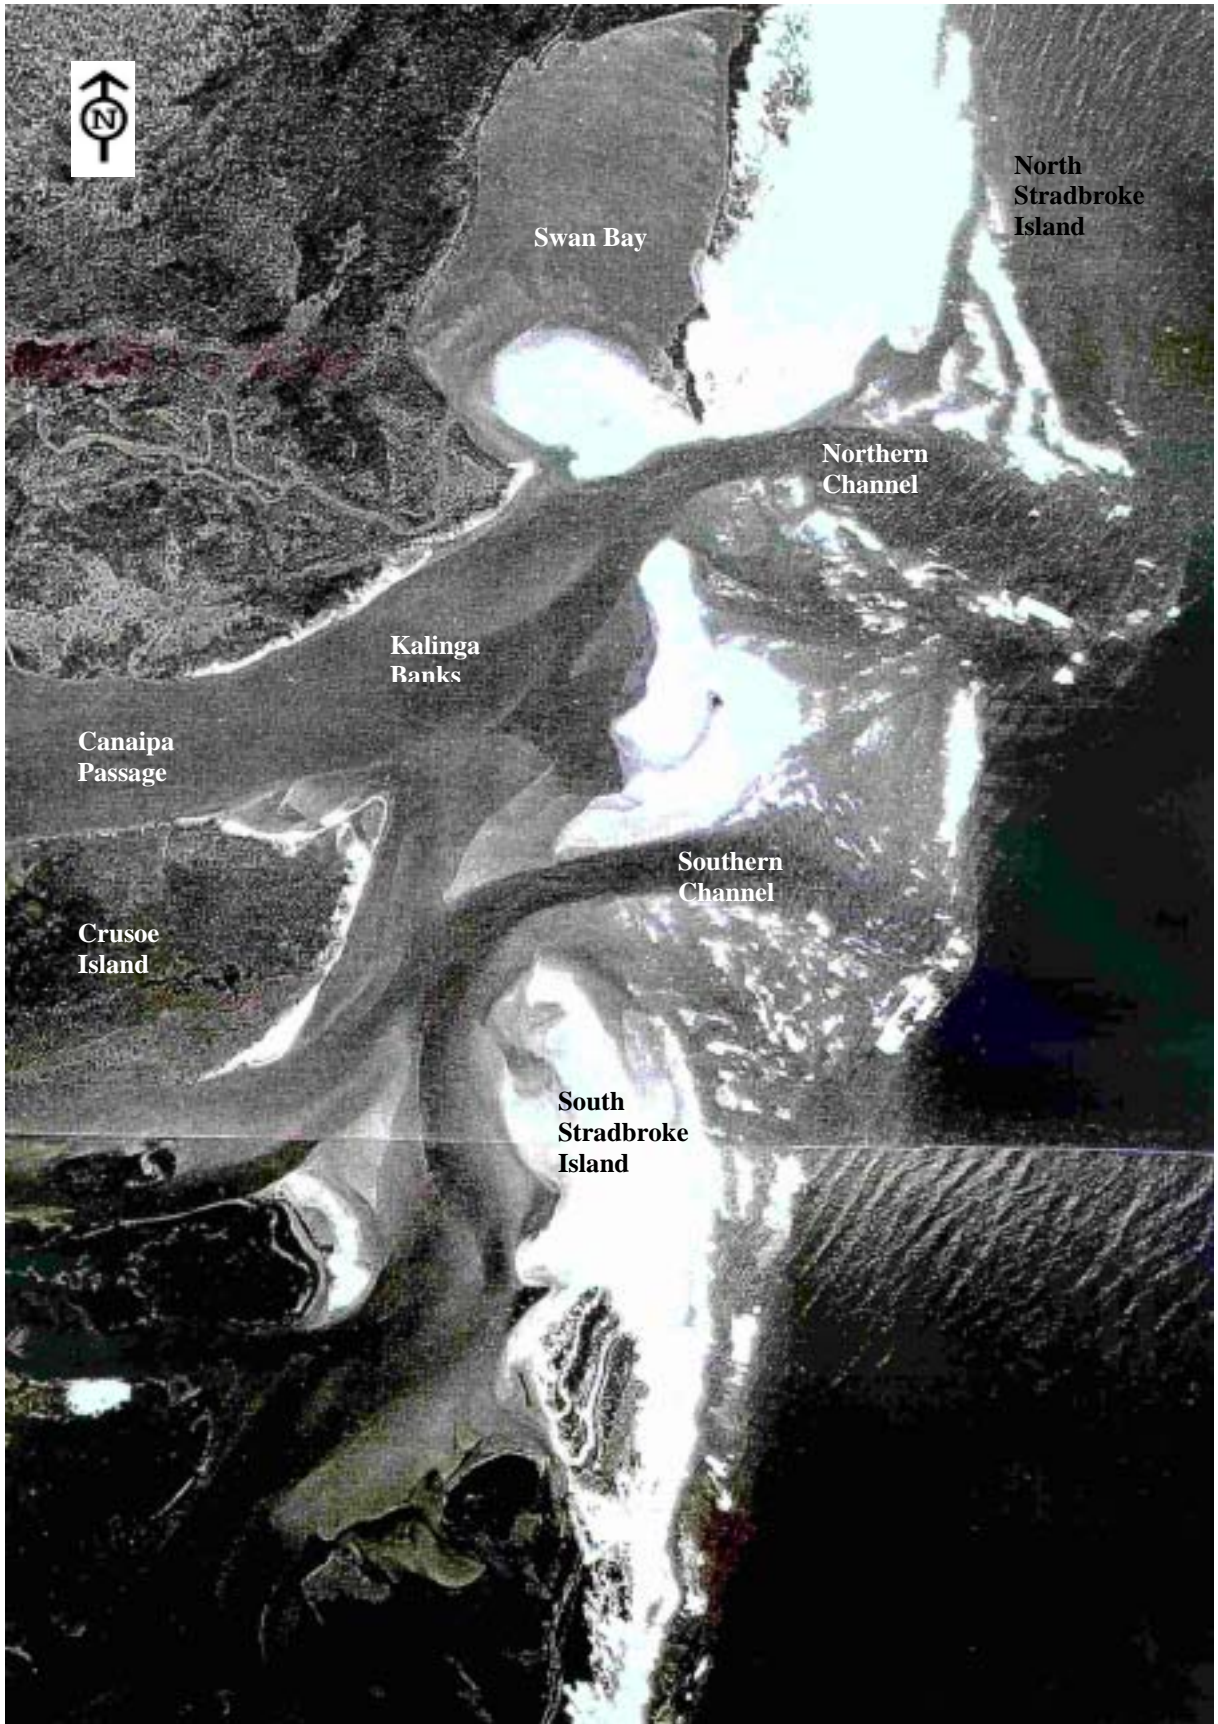
Figure B.5. 1978 Aerial photograph of Jumpinpin inlet

Massive changes took place between 1970 and 1978 (Figure 8.1; Figure B.5). Namely, a second channel breached in a location very close to the 1944 southern channel and where the 1890s original inlet breached. The conditions of 1978 appear very similar to the conditions of 1944. The southern channel is about the same width as the northern one, although its ebb-tidal delta is smaller. The northern channel has widened since 1970, eroding its northern bank. The downdrift offset has also receded.

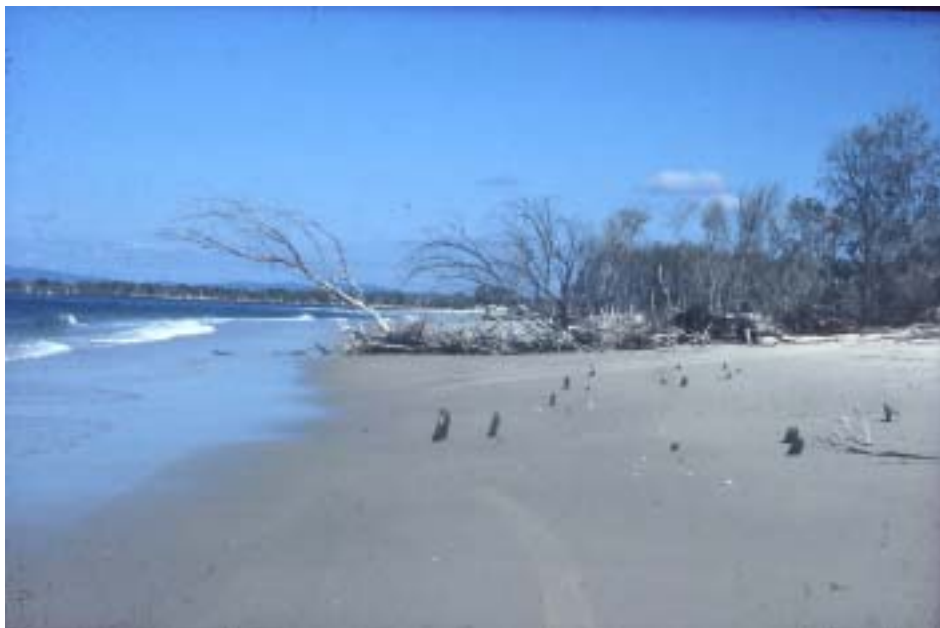
Figure B.10d. Jumpinpin downdrift bank 1997, looking west – evidence of erosion

In 1997 one channel is active. Conditions appear very similar to 1993 with continued infilling of Sway Bay and erosion of the downdrift bank.
